DELAWARE RIVER BASIN
ALLOWAY CREEK, SALEM COUNTY
NEW JERSEY

ALLOWAY LAKE DAM

NJ 00038

PHASE 1 INSPECTION REPORT
NATIONAL DAM SAFETY PROGRAM

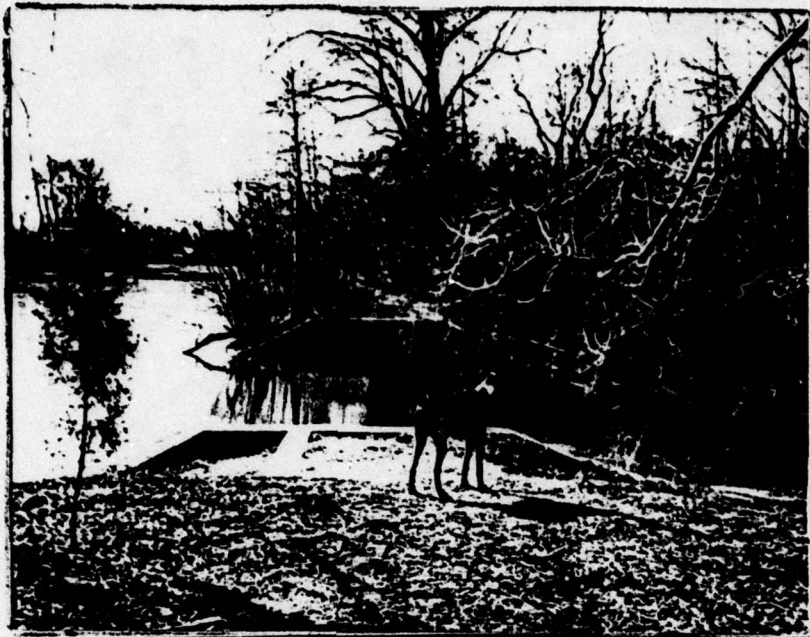
View South at spillway

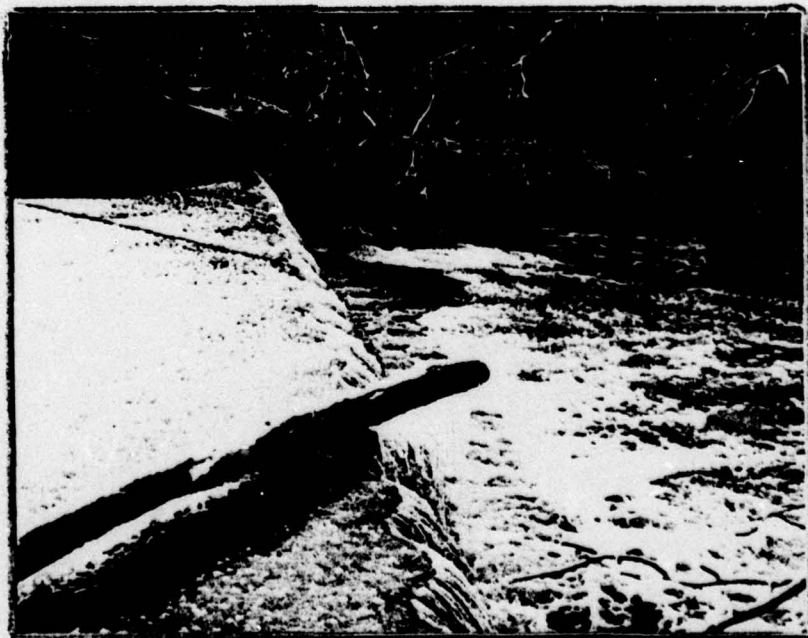
The erosion of the downstream stilling basin below the main spillway is slowly undercutting the steel sheeting driven across the bottom of the ogee apron slab. The depth of this sheeting is unknown but roughly 9 to 12 feet is exposed. The spillway was originally designed to have the outlet invert at El. +9 (flush with the spillway apron), but this did not take into account the steep natural gradient of the channel immediately below the dam. The apparent sweepout of the channel bed may have commenced immediately after the 1933 construction, leaving the spillway apron in a perched condition. Additionally, the wingwalls along each side of the apron rely, in part, on the support of the apron for their stability (their width of footing is insufficient as a free-standing gravity retaining wall) and the bottom of footing (at El. +6.0) is completely exposed at the ends, being over 6 feet above the stilling basin elevation. Further, the timber sheeting cut-off under the walls is only 8 feet long. In summary, these wingwalls are in a somewhat precarious condition and have already cracked loose from their upper connection at the ogee spillway wall and the short cut-off wall that parallels the dam axis. Should the undercutting continue it is only a matter of time before they collapse.

End of spillway slab

(1) The downstream channel immediately below the main spillway should be filled with riprap to prevent further undercutting of the concrete spillway apron. Consideration could be given to driving additional sheeting parallel and downstream of the spillway wingwalls and backfilling behind the added sheeting.

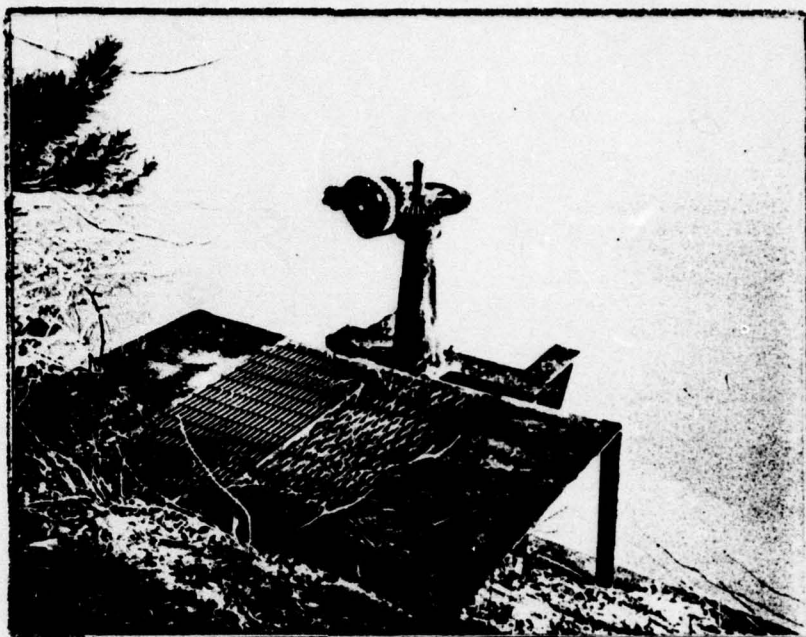
48" \varnothing vertical lift sluiceway

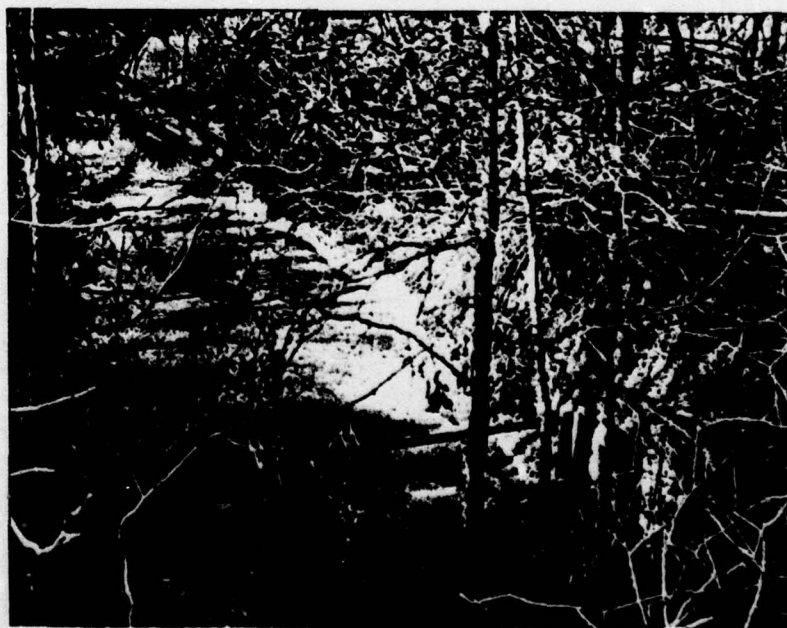
The auxiliary outlet with the 48-inch sluice gate has been additionally reinforced with steel sheeting driven along the downstream banks but the concrete slab cast between the sheeting is undermined. The steel access walk to the gate wheel is rusted but in a satisfactory structural condition. As with the main spillway channel, the auxiliary channel shows evidence of excessive outlet velocities over an extended period of time. The area of this sluiceway is where the 1950 washout occurred.

Downstream channel below sluiceway

(2) The undercut apron slab at the auxiliary gate outlet should be backfilled and channel protection dumped in the stream bed.
